Infrared Inspection Report

Electrical Distribution Equipment

Sample Company

November, 2014

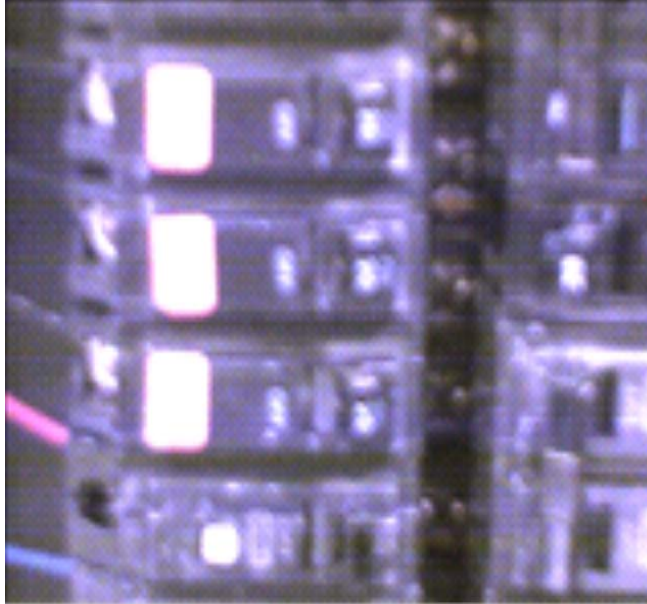
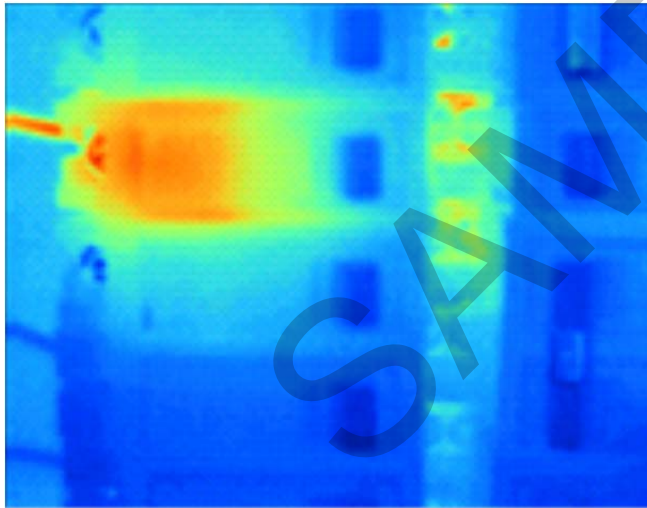
<i>Location:</i>	Second Floor Data Center
<i>Equipment:</i>	PDU 201-A
<i>Component:</i>	Circuit Breaker 11
<i>Mfg/type:</i>	GE – 20A 1P

This anomaly involves heating at the bus connection of the panelboards branch circuit breaker, with the possibility of overload on the branch circuit. It is located in PDU 201-A circuit 11. Heating at the breaker bus connection as well as heating of the neutral side indicates the possibility of an overload on the circuit.

<i>Electrical Load (Amps)</i>		
<i>Aθ</i>	<i>Bθ</i>	<i>Cθ</i>
		17.2
<i>Notes:</i>

<i>Thermal Findings</i>
Significant heating at the circuit breaker connection to the bus
Temperature there= 93.6°
ΔT above ambient=29.9°
<i>Ambient: 68.7°</i>

While this does not warrant immediate attention, if possible some of the load on this circuit should be dispersed. The temperature rise indicated on the report was slight. Also bear in mind that a failure at this location could cause considerable damage to the surrounding components.

<i>Image Notes:</i>
<i>Comments/Recommendations:</i> 20 amp breaker is 86% loaded. No danger, however load should be shed if possible.
<i>Thermographer:</i> Titan Power Inc.
