# Infrared Inspection Report

Electrical Distribution Equipment

**Sample Company**

**November, 2014**

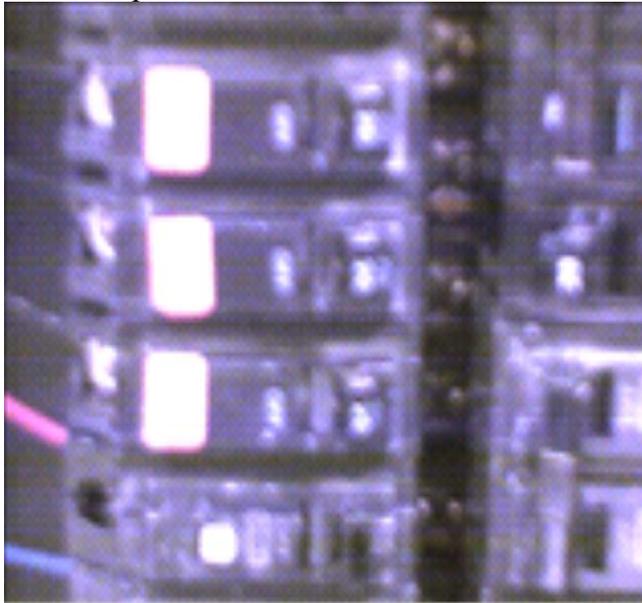
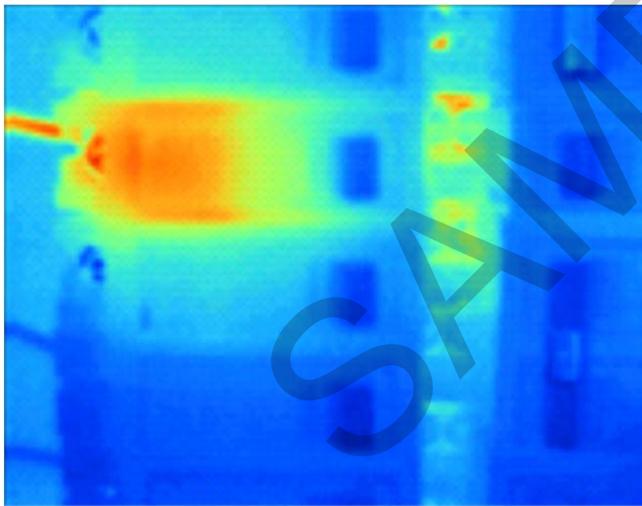
<i>Location:</i>	Second Floor Data Center
<i>Equipment:</i>	PDU 201-A
<i>Component:</i>	Circuit Breaker 11
<i>Mfg/type:</i>	GE – 20A 1P

This anomaly involves heating at the bus connection of the panelboards branch circuit breaker, with the possibility of overload on the branch circuit. It is located in PDU 201-A circuit 11. Heating at the breaker bus connection as well as heating of the neutral side indicates the possibility of an overload on the circuit.

<i>Electrical Load (Amps)</i>		
<i>A<math>\theta</math></i>	<i>B<math>\theta</math></i>	<i>C<math>\theta</math></i>
		17.2
<i>Notes:</i>

<i>Thermal Findings</i>
Significant heating at the circuit breaker connection to the bus
Temperature there= 93.6°
$\Delta T$ above ambient=29.9°
<i>Ambient: 68.7°</i>

While this does not warrant immediate attention, if possible some of the load on this circuit should be dispersed. The temperature rise indicated on the report was slight. Also bear in mind that a failure at this location could cause considerable damage to the surrounding components.

<i>Image Notes:</i>
<i>Comments/Recommendations:</i>
20 amp breaker is 86% loaded. No danger, however load should be shed if possible.
<i>Thermographer:</i> Titan Power Inc.
