## Infrared Inspection Report

Electrical Distribution Equipment

**Sample Company**

**November, 2014**

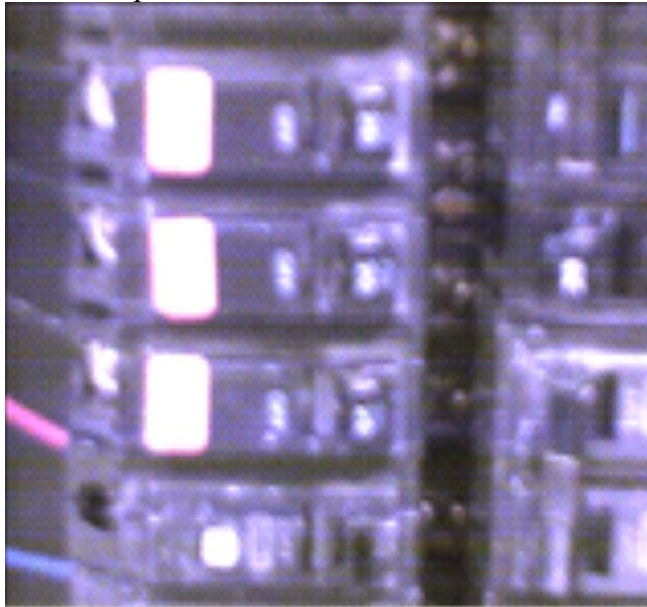
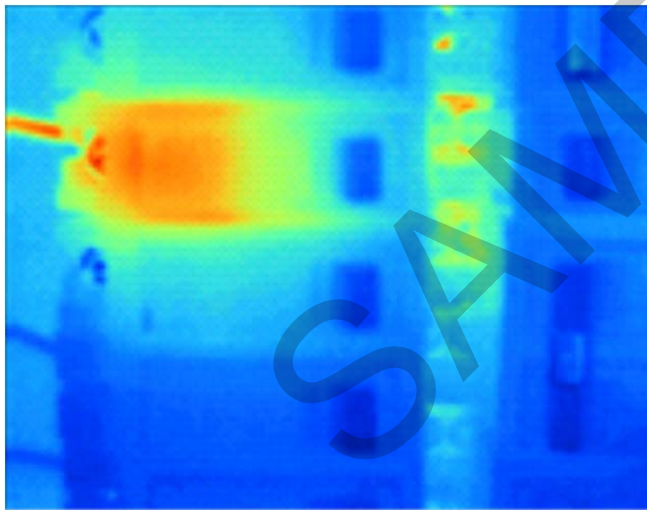
<i>Location:</i>	Second Floor Data Center
<i>Equipment:</i>	PDU 201-A
<i>Component:</i>	Circuit Breaker 11
<i>Mfg/type:</i>	GE – 20A 1P

This anomaly involves heating at the bus connection of the panelboards branch circuit breaker, with the possibility of overload on the branch circuit. It is located in PDU 201-A circuit 11. Heating at the breaker bus connection as well as heating of the neutral side indicates the possibility of an overload on the circuit.

<i>Thermal Findings</i>
Significant heating at the circuit breaker connection to the bus
Temperature there= 93.6°
$\Delta T$ above ambient=29.9°
<i>Ambient: 68.7°</i>

While this does not warrant immediate attention, if possible some of the load on this circuit should be dispersed. The temperature rise indicated on the report was slight. Also bear in mind that a failure at this location could cause considerable damage to the surrounding components.

<i>Image Notes:</i>
<i>Comments/Recommendations:</i>
20 amp breaker is 86% loaded. No danger, however load should be shed if possible.
<i>Thermographer:</i> Titan Power Inc.
